**RIDEAU HALL
Perimeter Fence
Restoration
1996**

Rideau Hall Perimeter Fence Restoration Investigation and Recommendations

Design and Construction Division

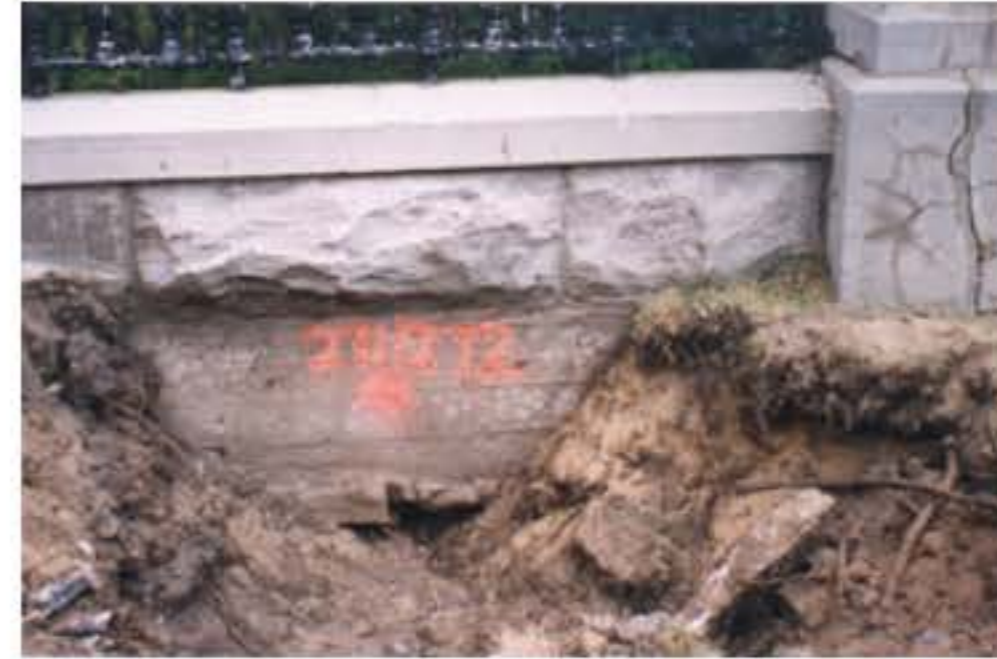
Foundation excavation at 1933 Section

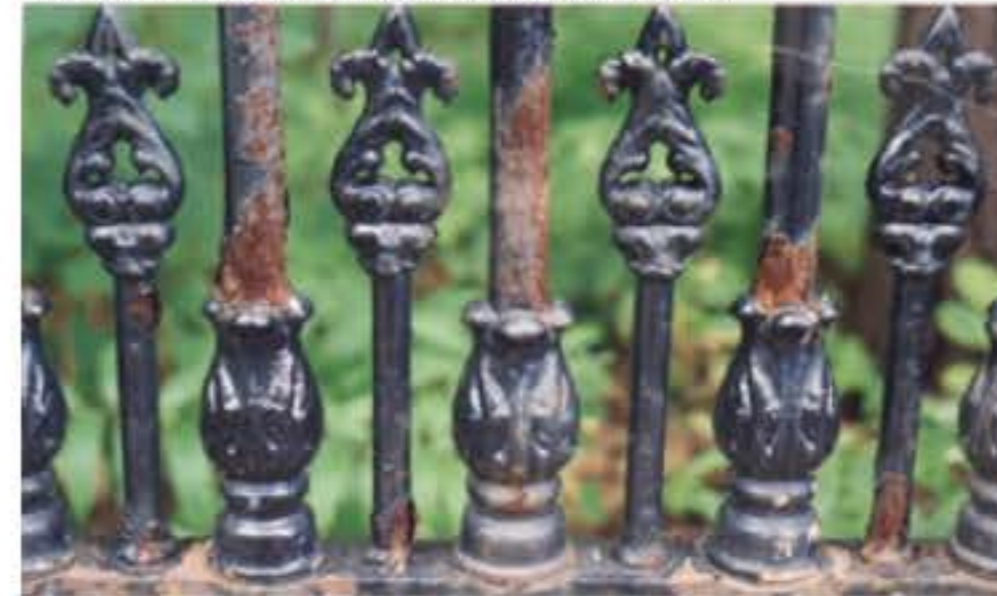
Typical deteriorated metal work, 1933 Section

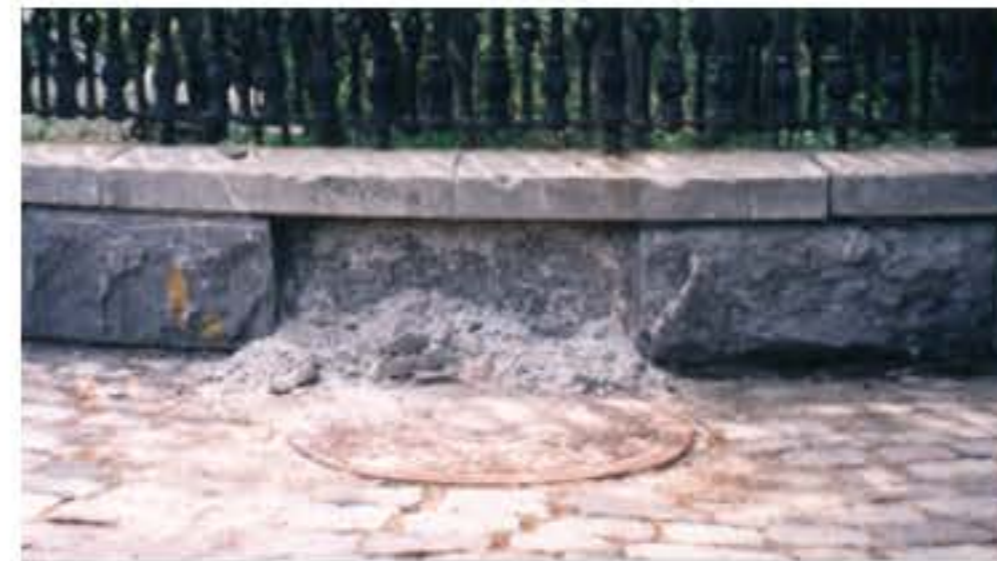
Typical failure at low wall

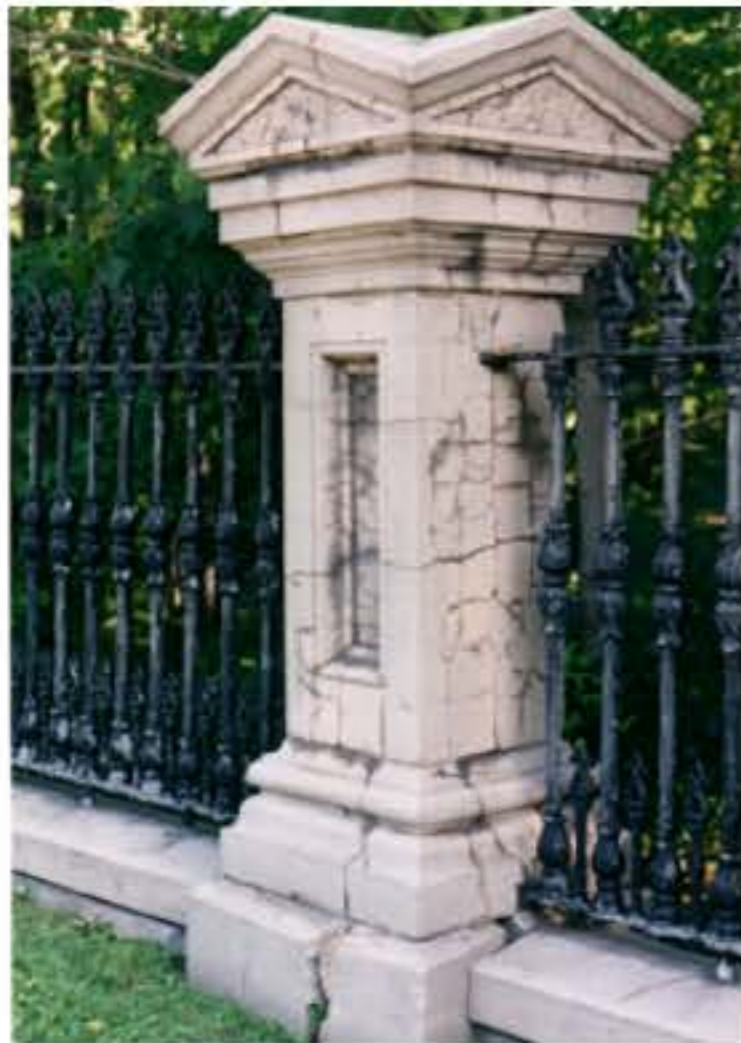
Typical fractures at masonry pillar (1933 Section).

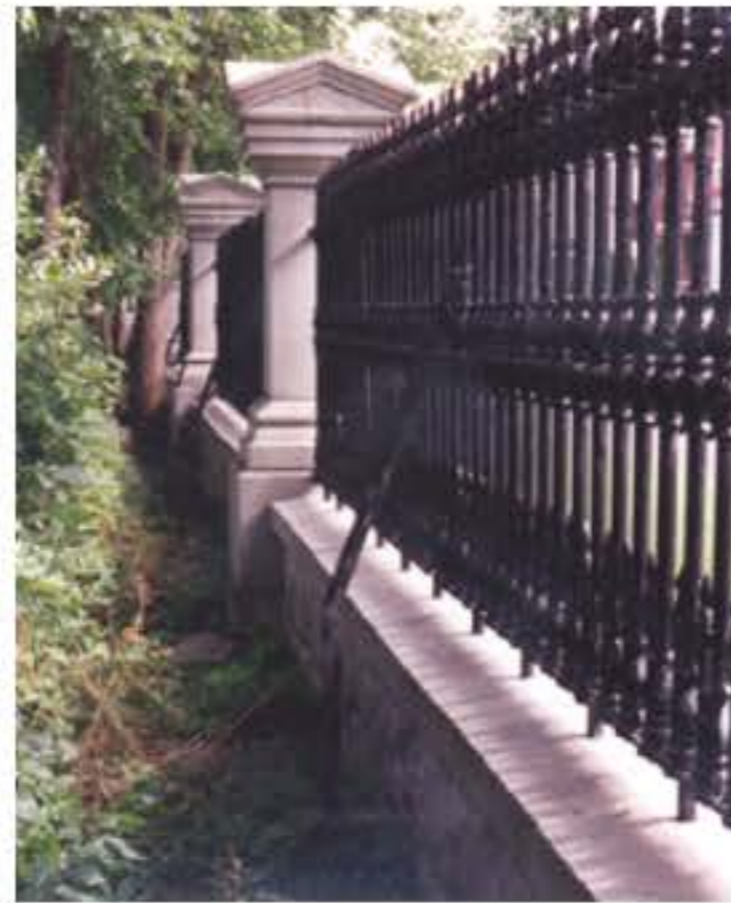
Typical overgrown vegetation

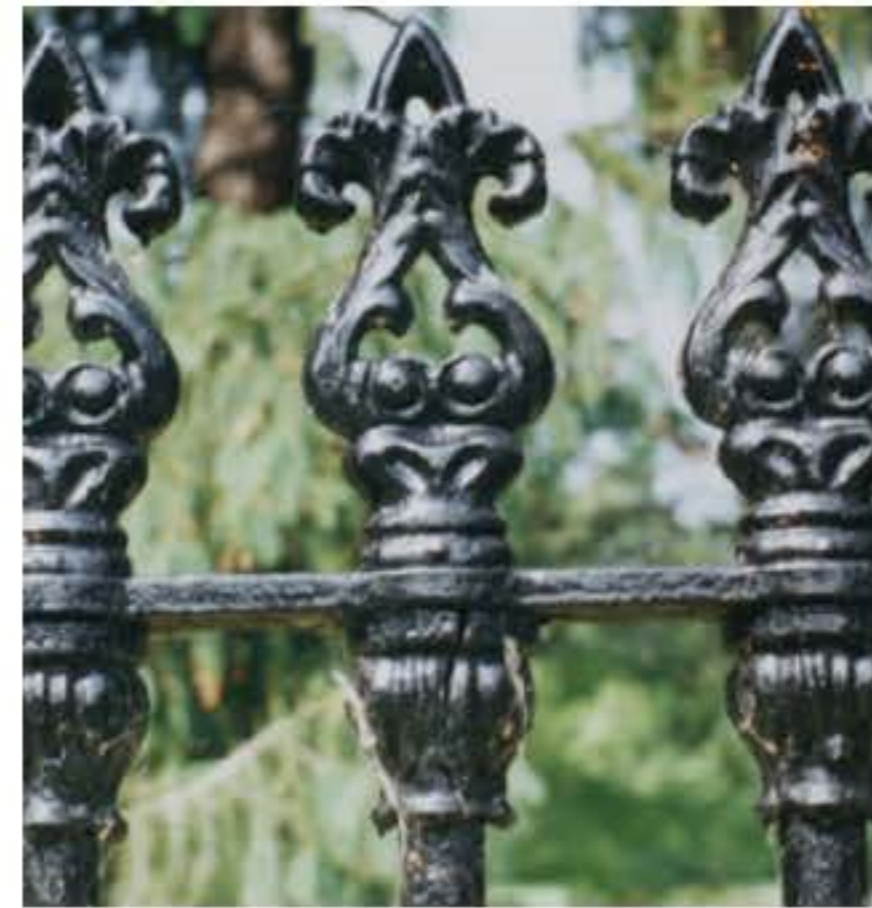
Typical fractured metal casting. Neglect of these deficiencies will lead to deterioration of adjacent elements

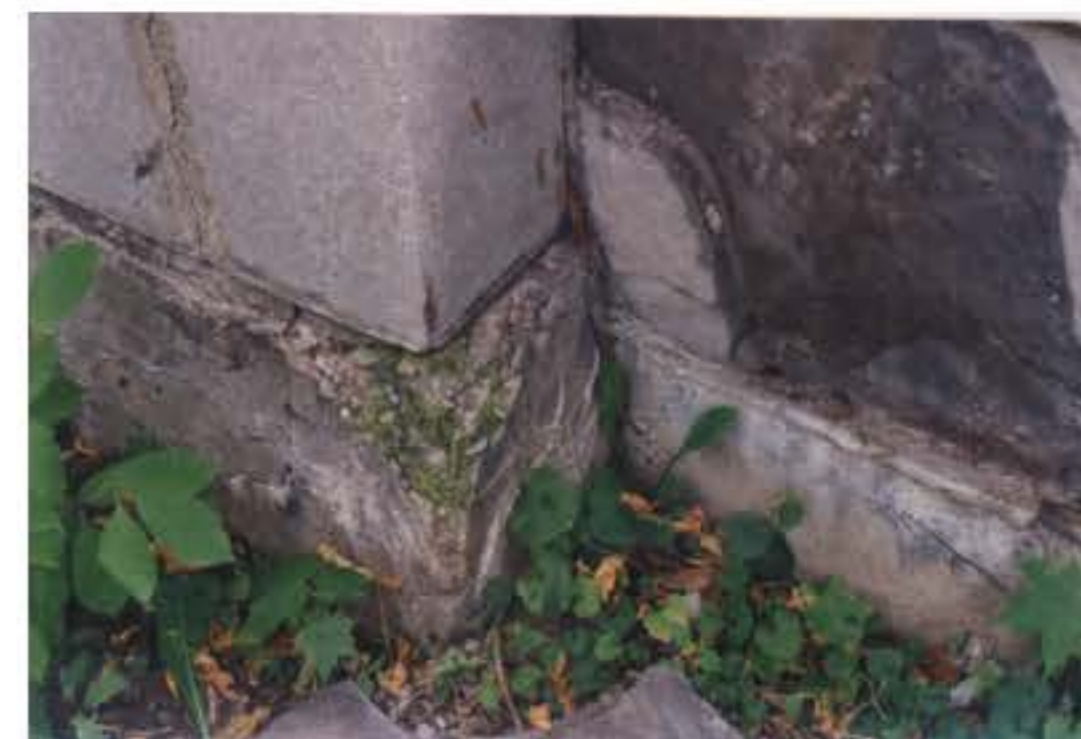
Typical spalled concrete at top of foundation

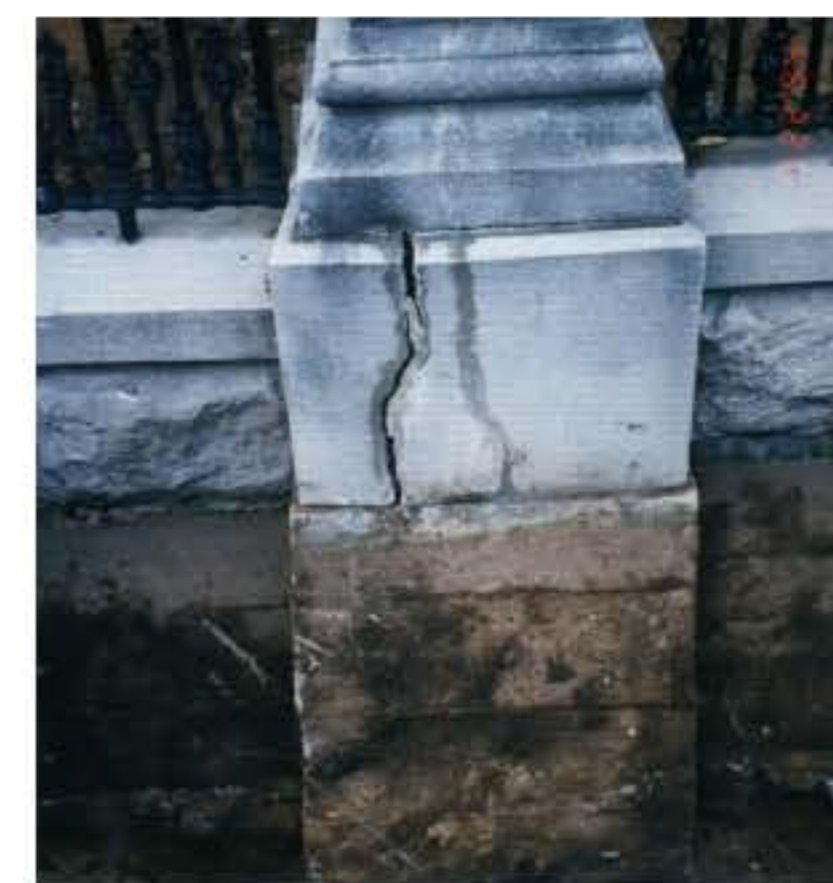
Typical cracked pillar base, partly caused by movement in foundation below

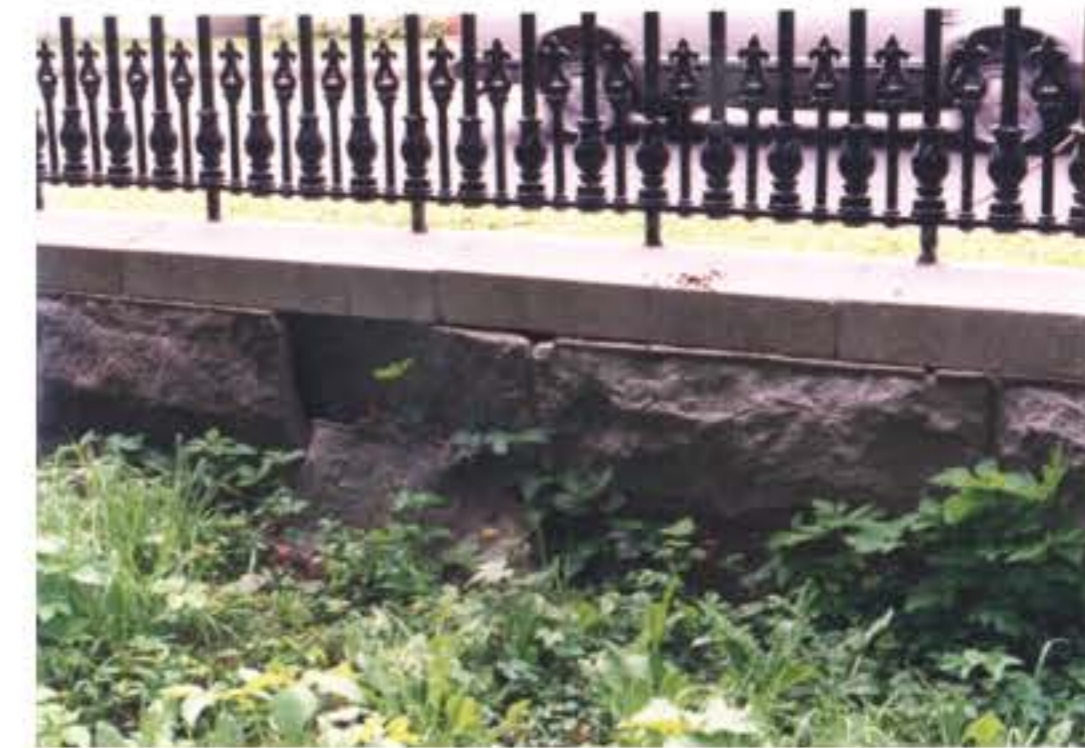
Symptoms	Causes of Symptoms	Recommended Solutions
<ul style="list-style-type: none"> limestone facings bulge outwards 	<ul style="list-style-type: none"> wall remains continually saturated with moisture 	<ul style="list-style-type: none"> rake, repoint and reset facing stones
<ul style="list-style-type: none"> delamination of limestone facing 	<ul style="list-style-type: none"> incorrect bedding plane 	<ul style="list-style-type: none"> replace as required
<ul style="list-style-type: none"> upstand wall in friable condition 	<ul style="list-style-type: none"> moisture saturation, freeze-thaw deterioration, and poorly air-entrained concrete 	<ul style="list-style-type: none"> dismantle and redesign/ reassemble where required. Regrading where required
<ul style="list-style-type: none"> severe outward tilting at the curved 1935 sections 	<ul style="list-style-type: none"> alkali aggregate reaction in foundation concrete has resulted in tilting 	<ul style="list-style-type: none"> cut expansion joints, disassembly / reassembly of tilting sections above with new mortar leveling base

Typical failure at low masonry wall, Muckay Street.

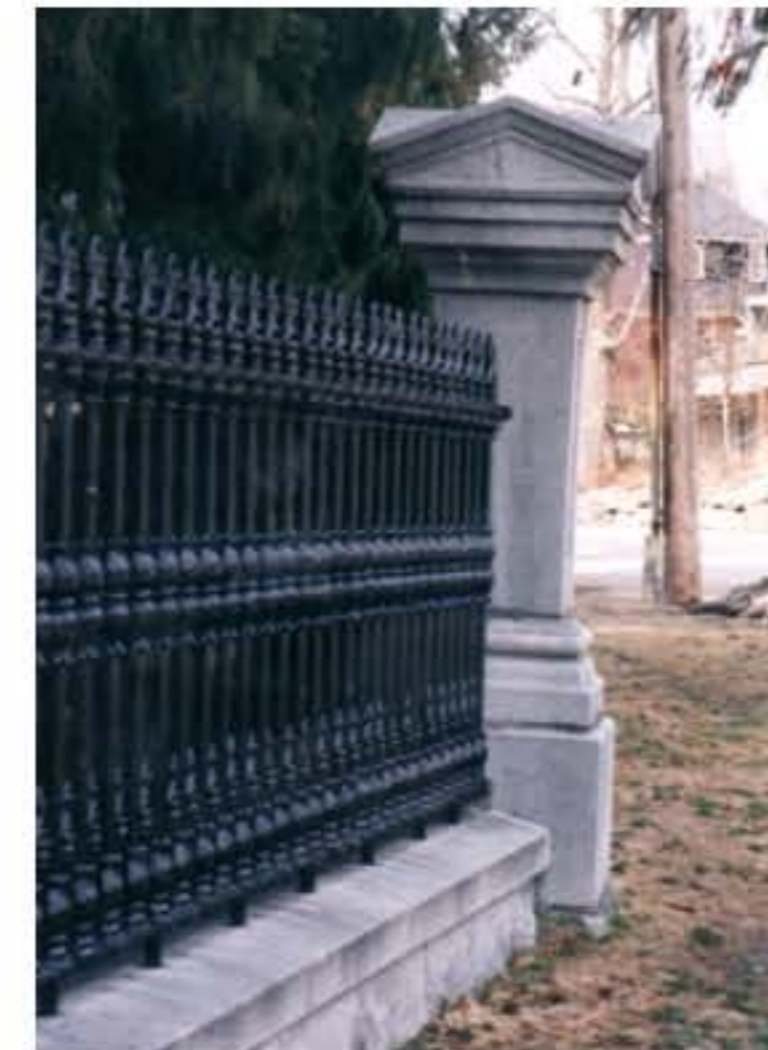
<ul style="list-style-type: none"> • <i>severe outward tilting at the curved 1935 sections</i> 	<ul style="list-style-type: none"> • <i>alkali aggregate reaction in foundation concrete has resulted in tilting</i> 	<ul style="list-style-type: none"> • <i>cut expansion joints, disassembly / reassembly of tilting sections above with new mortar leveling base</i>

Fence assembly out-of plumb at section 1935

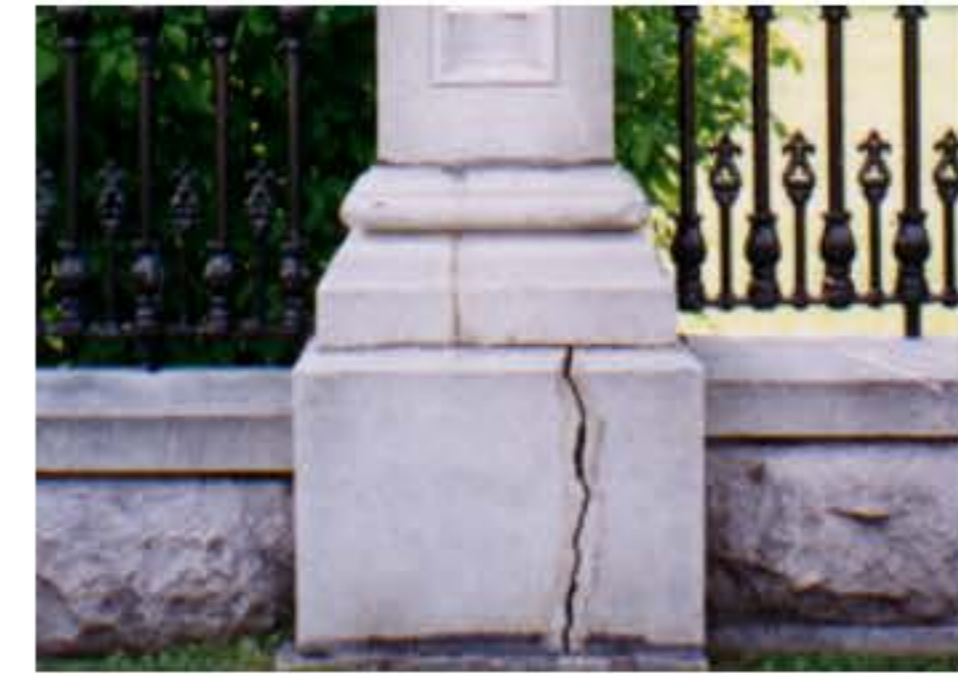
Symptoms	Causes of Symptoms	Recommended Solutions
<ul style="list-style-type: none"> pillar bases adjacent to low walls are cracked 	<ul style="list-style-type: none"> alkali aggregate reaction in upstand wall 	<ul style="list-style-type: none"> expansion joints, dismantle and repair / reassemble
<ul style="list-style-type: none"> cracking above base blocks, notably 1932 & 1933 sections 	<ul style="list-style-type: none"> freeze-thaw cycling, salt crystallization damage, alkali aggregate reaction, extennal mechanical forces 	<ul style="list-style-type: none"> disassemble, repair and / or replace
<ul style="list-style-type: none"> staining at mortar joints 	<ul style="list-style-type: none"> egress of moisture 	<ul style="list-style-type: none"> selective cleaning
<ul style="list-style-type: none"> failed mortar joints 	<ul style="list-style-type: none"> egress of moisture, lack of maintenance 	<ul style="list-style-type: none"> rake and repoint

Typical Vertical Fracture at base of Pillar 144, caused by AAR-induced expansion in low wall adjacent, and in the foundation below

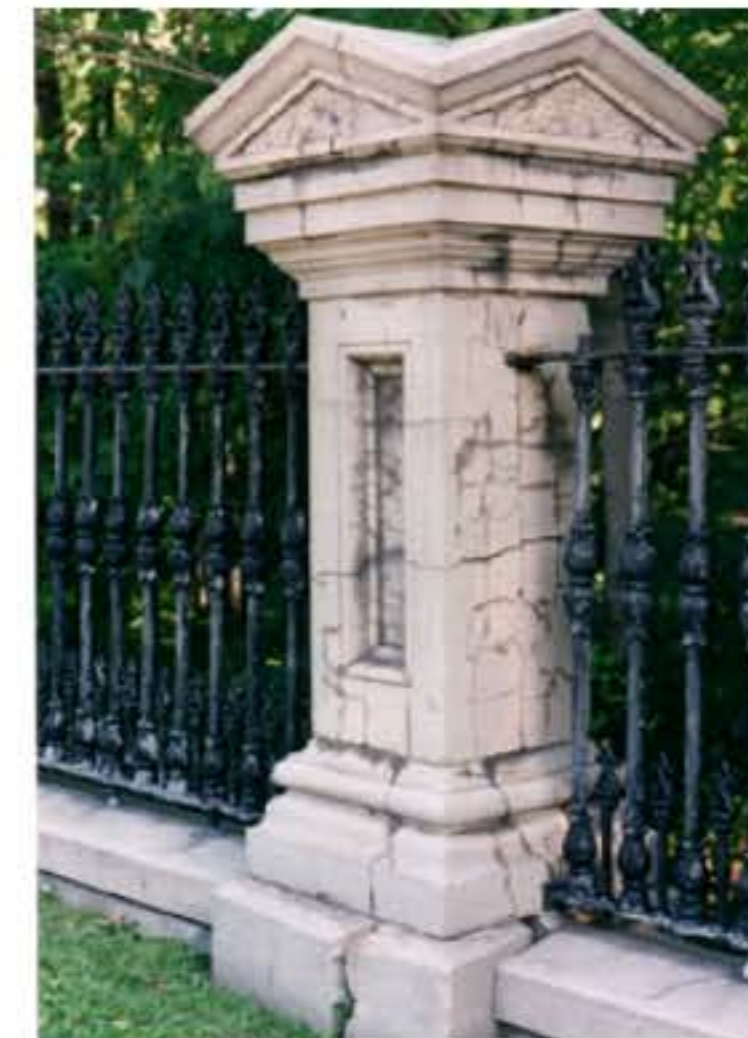
Typical fractures at masonry pillar (1933 Section).

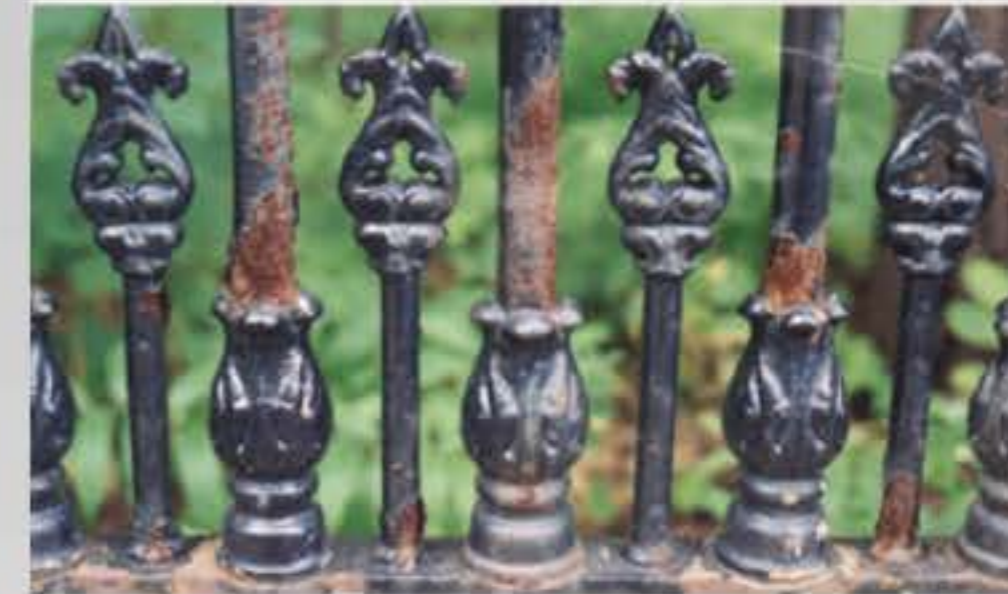
Typical corrosion at non-galvanized 1936 section

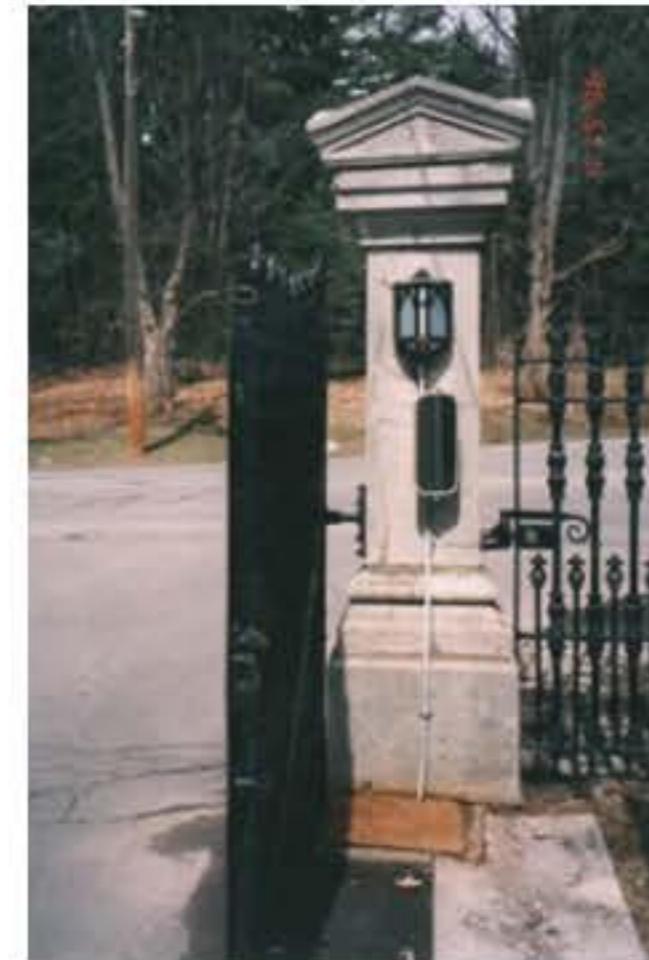
Surface-mounted electrical conduit at Prince Anne Gate :

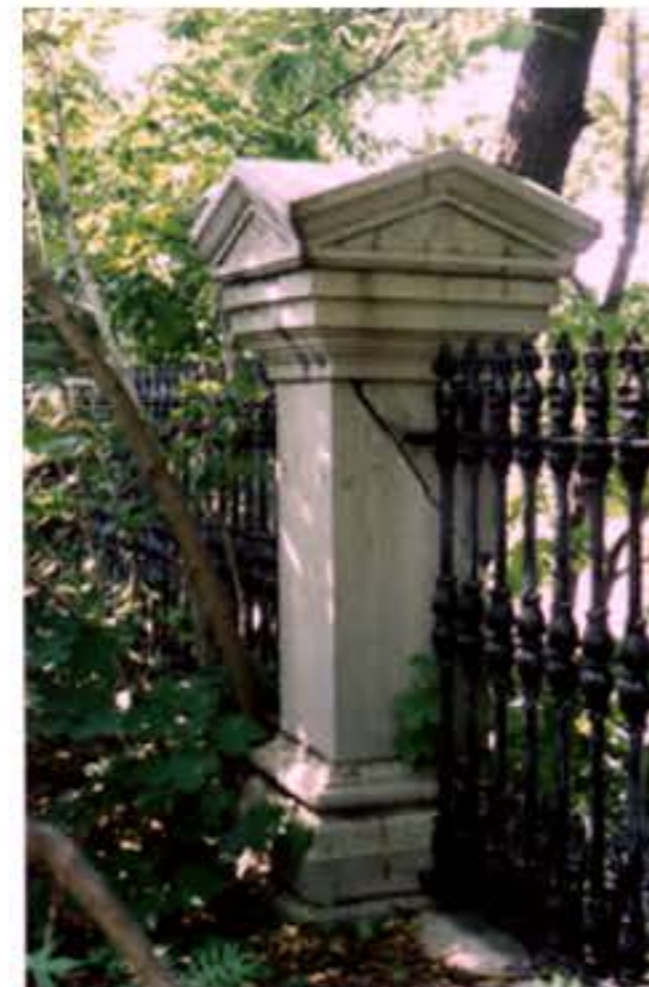
<ul style="list-style-type: none"> <i>overgrown vegetation, organic staining of masonry elements.</i> 	<ul style="list-style-type: none"> <i>lack of systematic maintenance</i> 	<ul style="list-style-type: none"> <i>instigate vegetation management</i>

Overgrown vegetation at 1939 Section

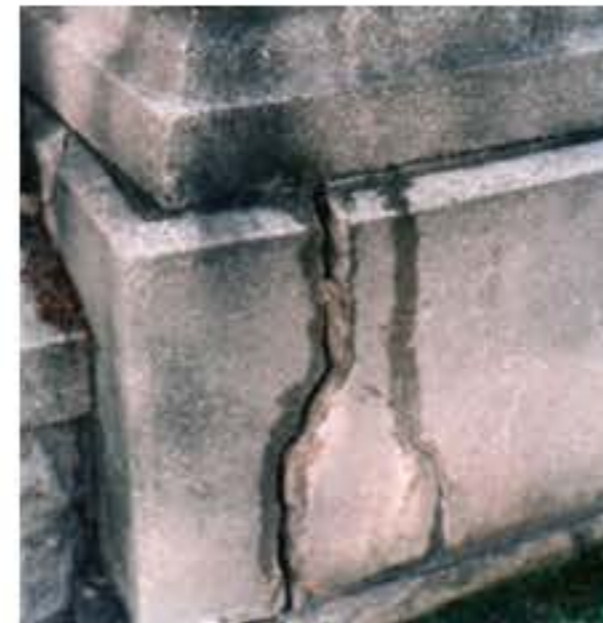
Typical Vertical Fracture at Base of Masonry Pillar
