Environmental Conditions

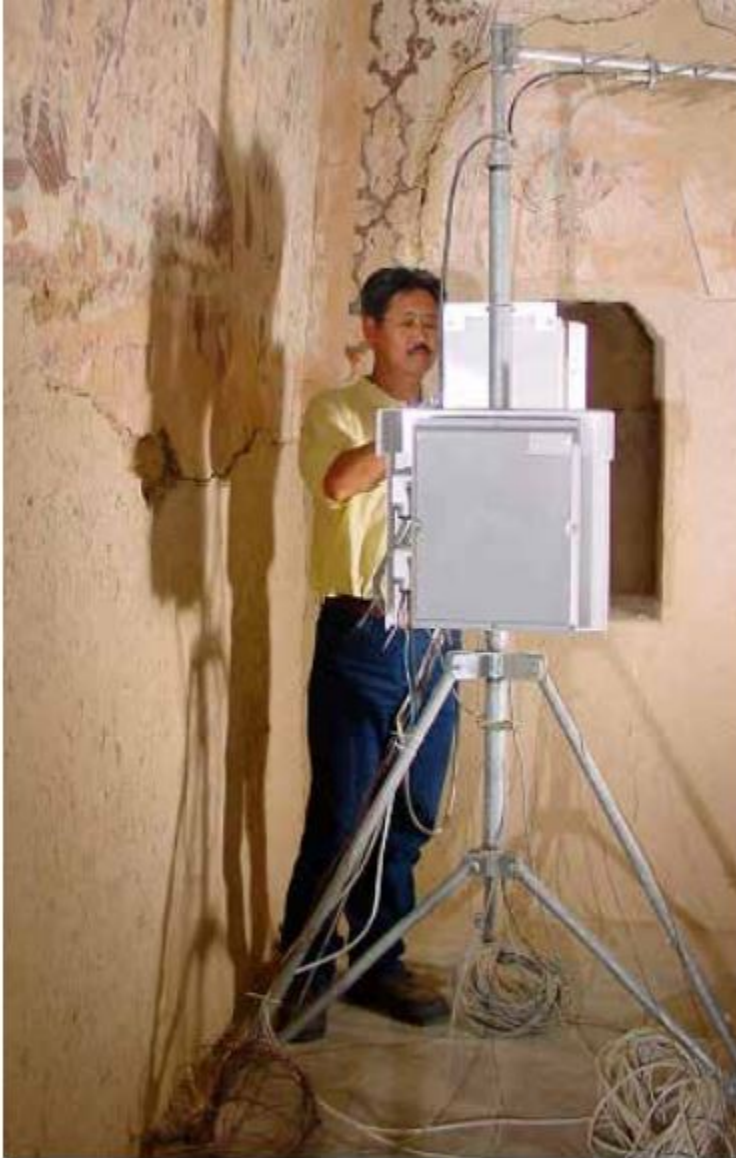
Fig. 14.1 Environmental monitoring station being installed in the antechamber in Cave 85.
