**SHAKE TABLE TEST SERVICES FOR GETTY
SEISMIC ADOBE PROJECT AND PROJECT
TERRA**

AGREEMENT NUMBER 0600031872

FINAL REPORT

APRIL 2005

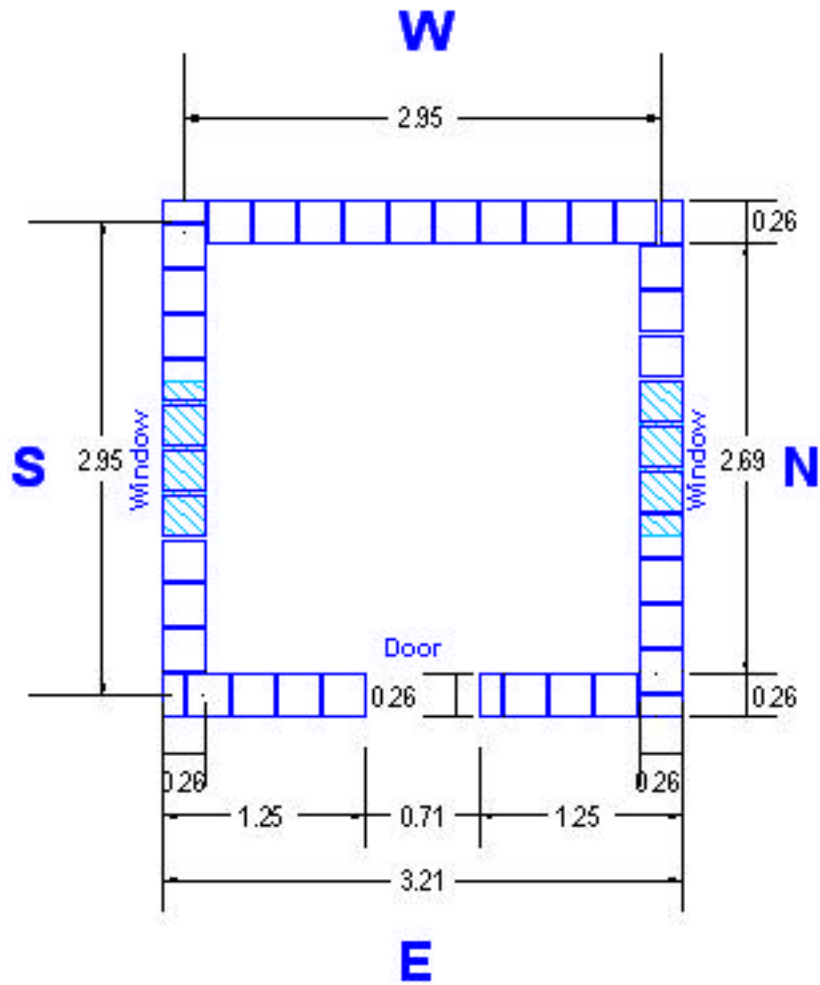
Figure 1a. Plan view and adobe block layout

The two test specimens had the same configuration and overall dimensions shown in Figure 1a and 1b. They consisted of four walls 3,21 m long, variable height, and 0,26 m thick, The North and South walls are identical and include a central window opening, making a symmetric structure in the direction subjected to the seismic loading. The two seismically transverse walls were different, the East wall with a door opening and the West wall without any opening and bigger height. Each specimen was built over a reinforced concrete foundation ring beam, which also served to anchor the specimen to the shaking table and as support during the transportation of the wall from the construction yard to the laboratory. A wooden crown beam was placed on top of each specimen to transmit the gravity loading corresponding to a typical dwelling roof.

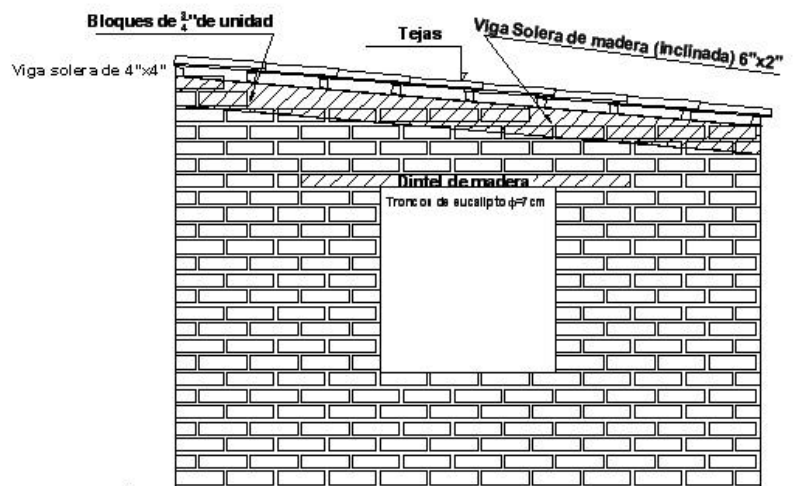
Figure 1b. South wall elevation

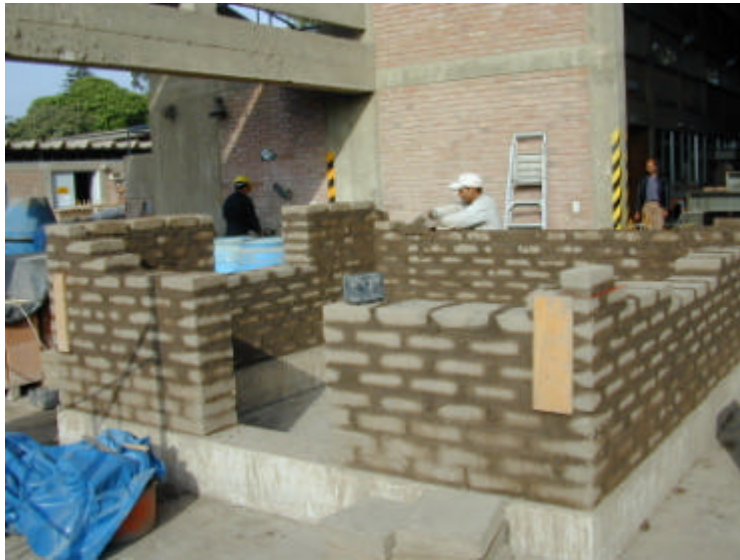
Figure 3. Typical construction process

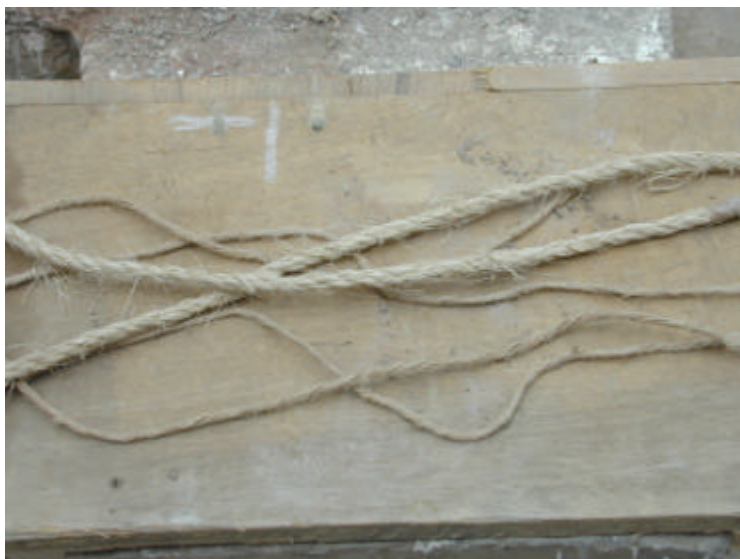
Figure 4. Cabuya rope for horizontal reinforcement and yute thread.

Model 1 was externally reinforced with a natural mesh composed of natural cane as vertical elements and “cabuya” rope as horizontal elements on both sides of the wall. The canes and cabuya rope were connected through the wall with a small diameter yute thread (see figure 4).

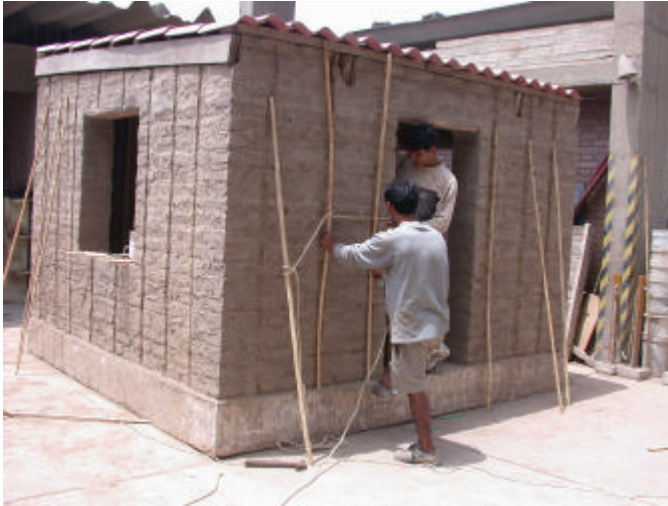
Figure 5a. Placing the vertical reinforcement in small trenches previously cut in the wall.

The deep of the trenches is about 1 cm in order to maintain the strength of the wall.

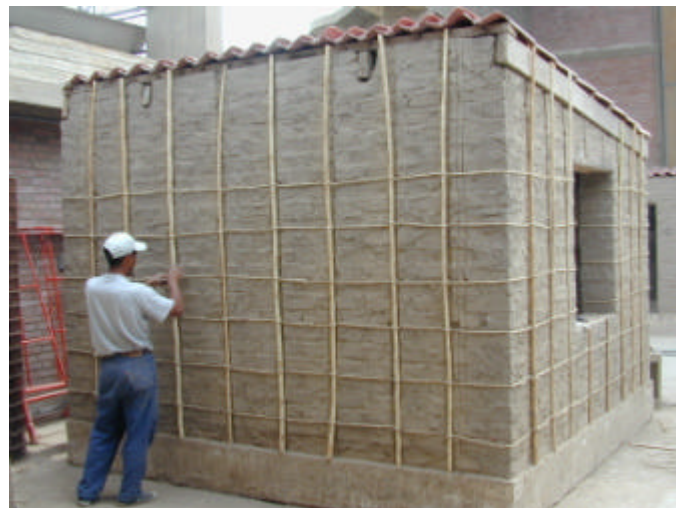
Figure 5b. After placing the vertical canes on both sides of the wall, they are tied with horizontal cabuya rope, to form the structural grid. The joints of the grid are connected through the wall with yute thread.

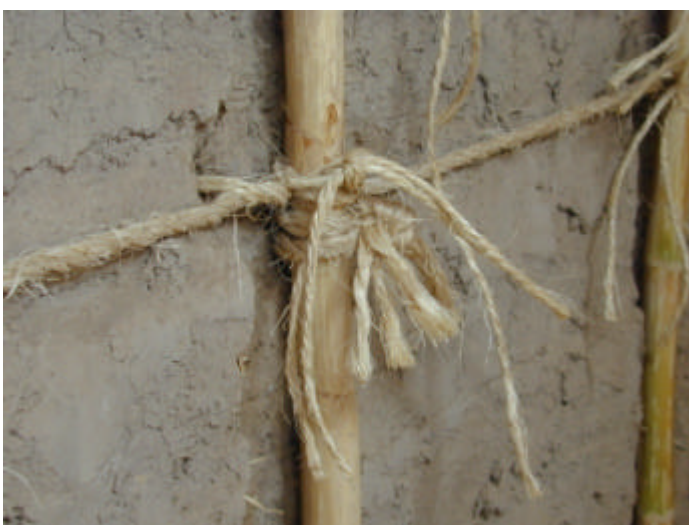
Figure 5c. Two holes are perforated at both sides of the vertical cane, so the yute thread holds the cane and the rope tightly

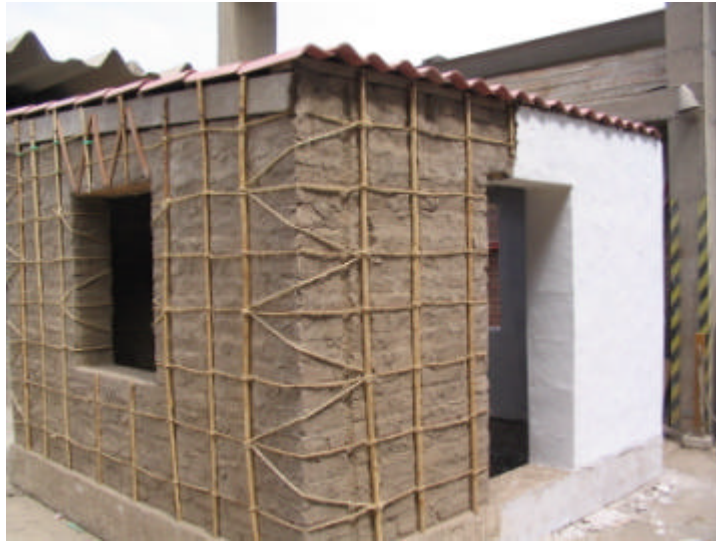
Figure 6. Model 1 reinforced with natural materials and plastered on one side.

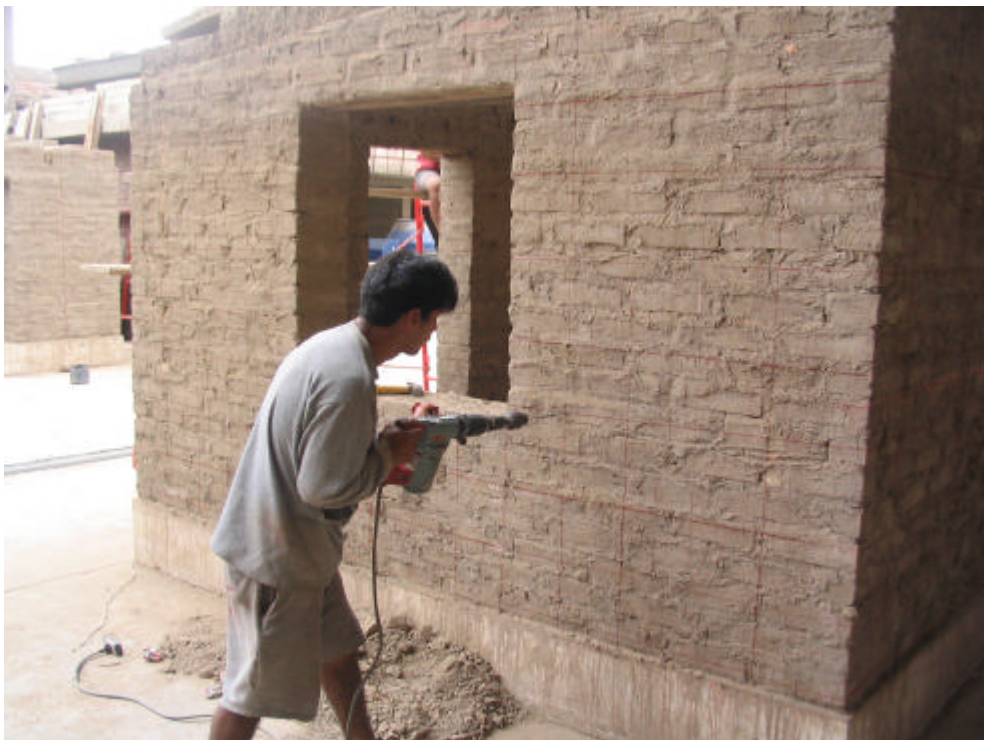
Figure 7. Drilling holes in the wall, spaced every 30 cm.

Model 2 was externally reinforced with an industrial material, in this case polymer geogrid TENSAR BX 1200 was used as external reinforcement. The mesh was placed on both sides of the wall by pieces and connected through the wall with plastic strings every 25 cm horizontal and vertically spaced (see figure 7 to 14).

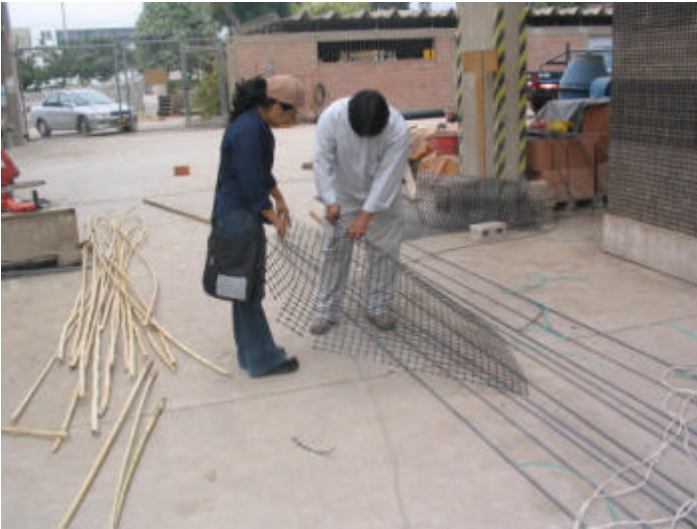
Figure 8. The geogrid comes in rolls of 3 by 50 meters. From it, it's cut in the necessary dimensions with a pair of scissors.

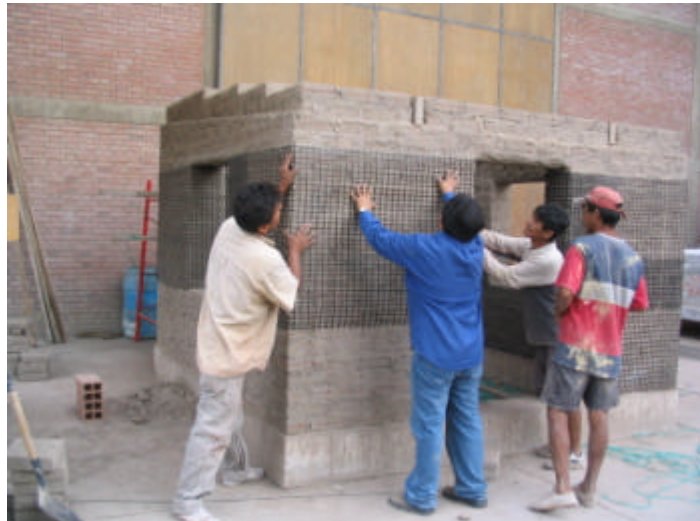
Figure 9. Portions of geogrid are placed on the walls in a continuous way and stretched as much as possible. Specially at the corners.

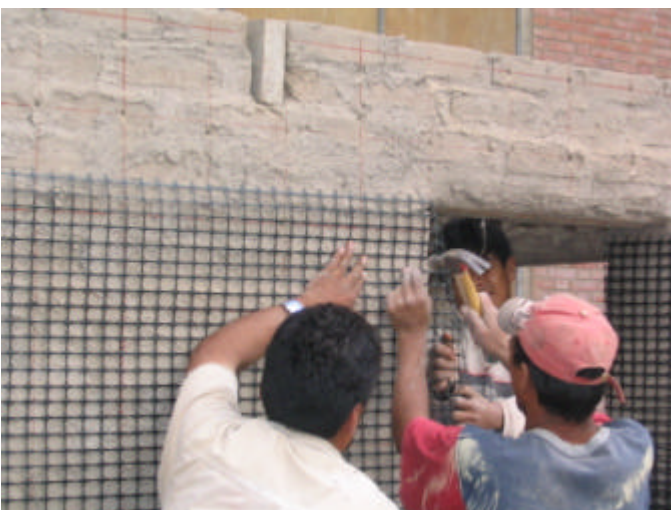
Figure 10. The mesh is provisionally fixed in position by nailing it to the wall.

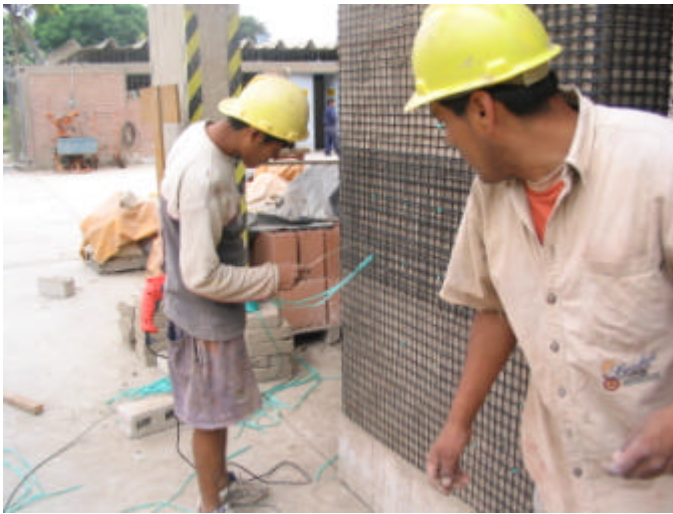
Figure 11. After placing the mesh completely, it is sowed through the wall in order to connect it with the mesh at the opposite side. A long needle and plastic thread is used for this purpose.

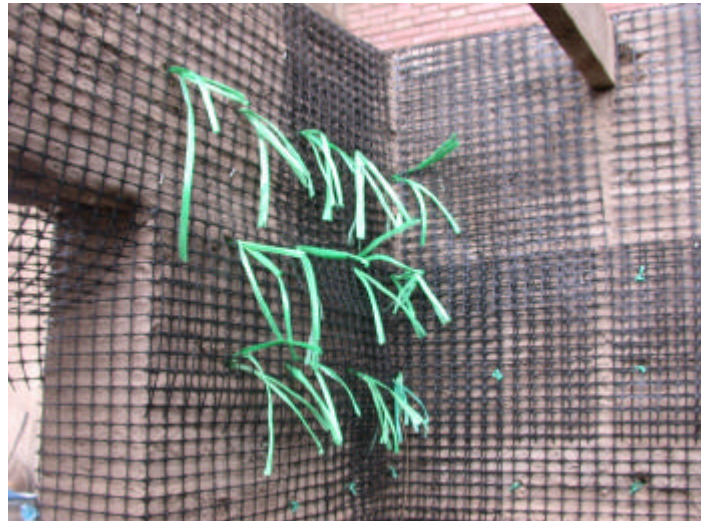
Figure 12. View of the plastic thread before tying. The overlapping of the mesh can also be appreciated.

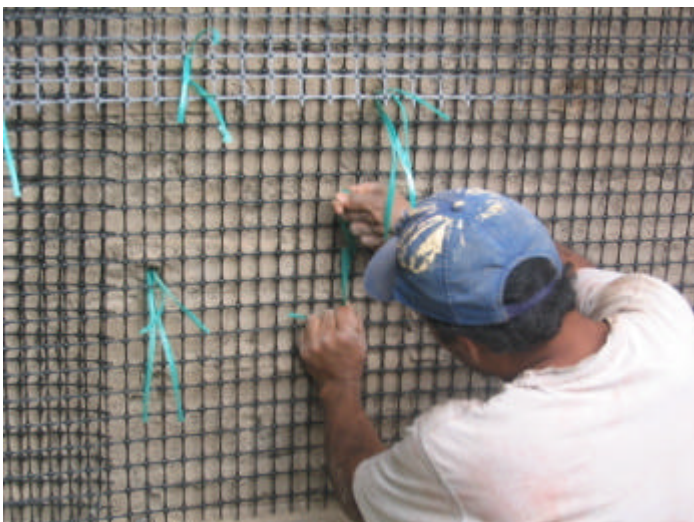
Figure 13. Tying the thread for confinement of the adobe wall with the geogrid.

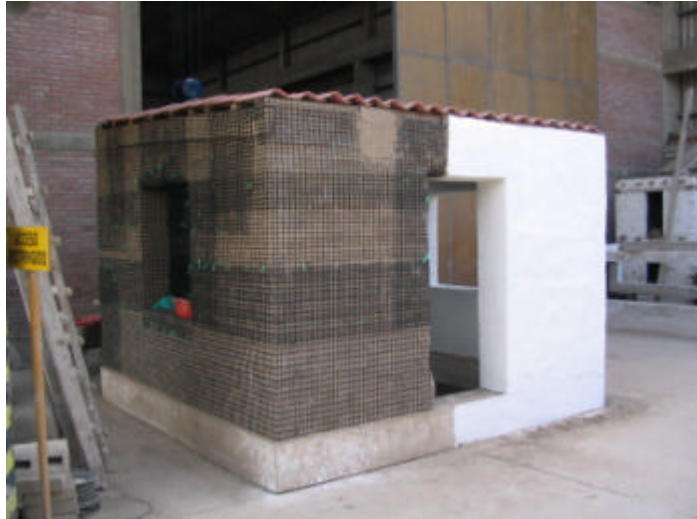
Figure 14. Model 2, reinforced with polymer geogrid and plastered for one side.

In both models, plaster on the surface was placed on half of the model in order to appreciate the behavior of the model with and without plaster.

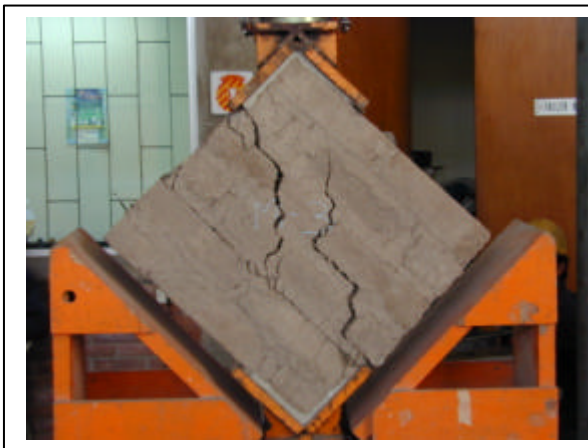
Figure 15a. Diagonal compression test.

Five axial compression tests on prisms and three diagonal compression tests on wallets were performed to establish the mechanical properties of the adobe masonry (figures 15a and 15b). The piles were constructed with five adobe blocks, with overall dimensions of 25 x 25 x 43 cm, the vertical deformation was measured in order to calculate the Elasticity Modulus. The wallets had dimensions of 25 x 50 x 50 cm. The average compression strength for the piles was 0.87 Mpa (8.7 kg/cm²) and the average Elasticity Modulus was 482 Mpa (4,320 kg/cm²). From the diagonal compression tests, the average shear strength was 0.068 Mpa (0.68 kg/cm²). The results of the tests are shown in tables 1 and 2.

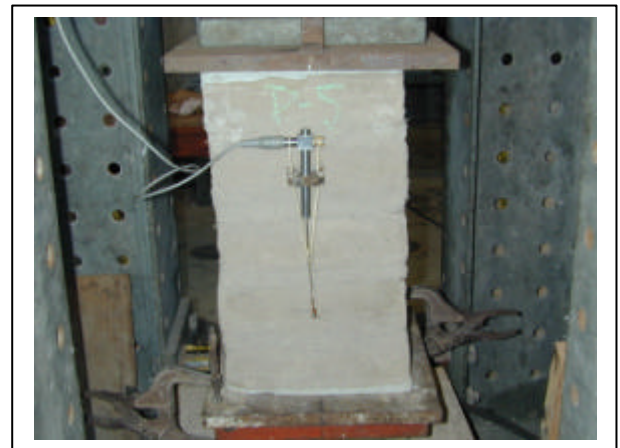
Figure 15b. Axial compression test.

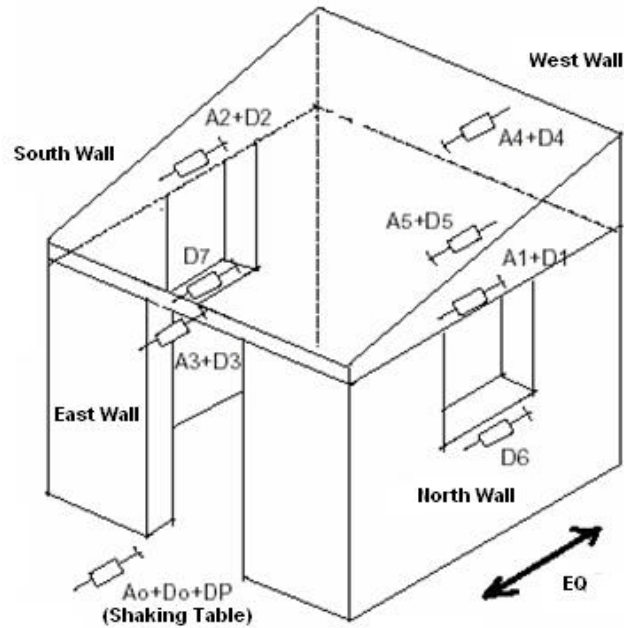
Figure16. Instrument configuration.

The models were instrumented with six accelerometers and eight displacement transducers as shown in figure 16. Acceleration and displacement were measured at the top of each wall and the mid height of West Wall, only displacements were measured below the windows on the North and South walls. Table displacement and acceleration and pressure on the hydraulic actuator were also measured

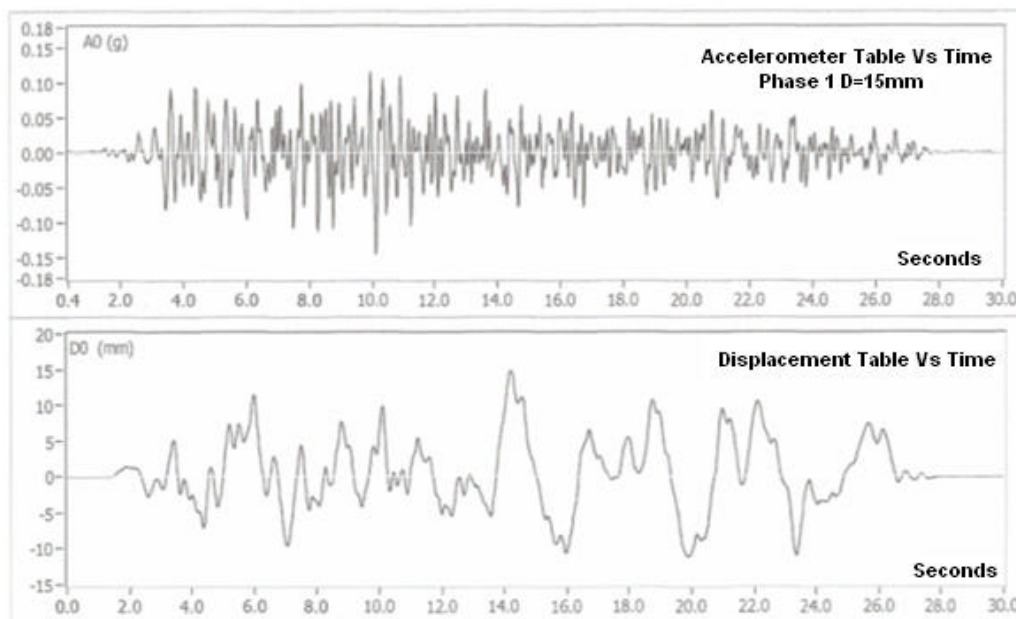
Figure 17. Acceleration and displacement time history of table motion.

Both models were subjected to several motions of increasing intensity, the signal was derived from a record of the Peruvian earthquake of May 31st, 1970, see figure 17.

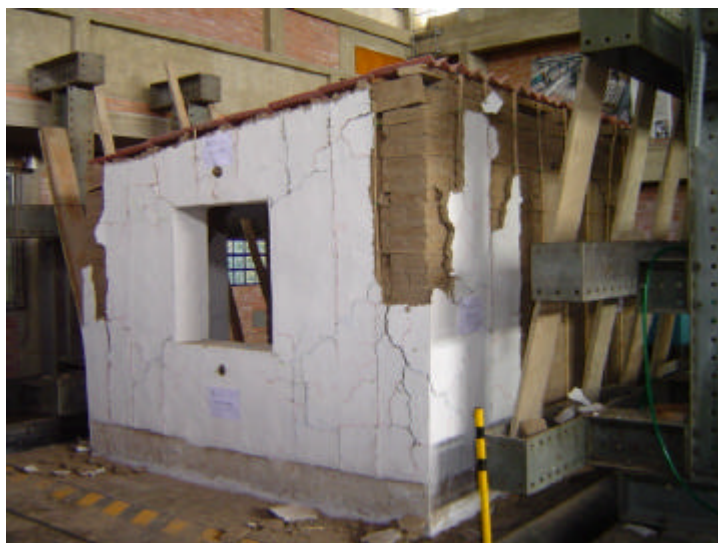
Figure 18. Model 1 after testing, view of north wall.

Model 1 behaved elastically until phase 3 with peak acceleration of 0.6g, in phase 4, a vertical crack, all the way from top to bottom, caused the separation of the west wall. However, the wall was kept in place by the horizontal rope reinforcement. Phases 5 and 6, both with 1g peak acceleration shake the model causing partial loss of the stucco and extensive cracking, dividing the wall into small pieces, partial and total collapse was avoided by the natural external mesh. It was clear that the seismic energy was dissipated by big horizontal displacements of transverse walls.

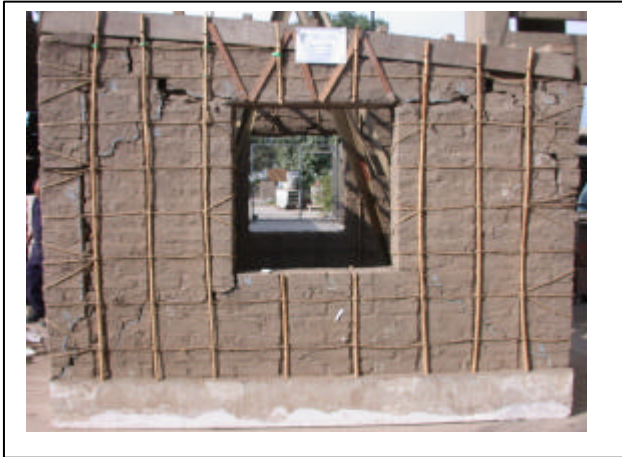
Figure 19. Model 1 South wall, without plaster. Damage is widespread but greater at the lintel level

After removing the plaster from the north wall, it was clear that the south wall suffered more damage than the north wall. The different type of connection of the lintel with the ring beam (diagonal wooden strips), caused a hammering action against the upper portion of the wall. Also the plaster in the north wall increased the stiffness and strength in that wall. See figures 7 and 8.

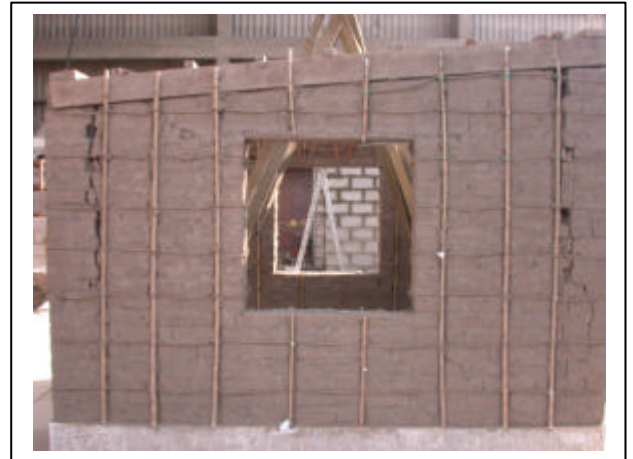
Figure 20. Model 1 North wall, plastered side. Vertical cracks appear at the intersection with transversal walls.

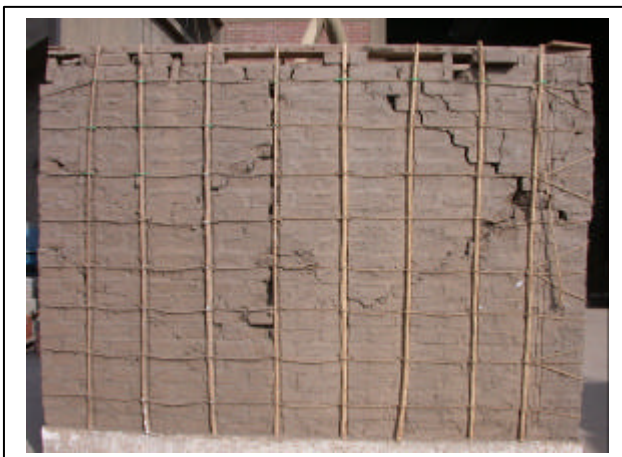
Figure 21. Model 1 West wall, The right half without plaster show greater damage than the left half.

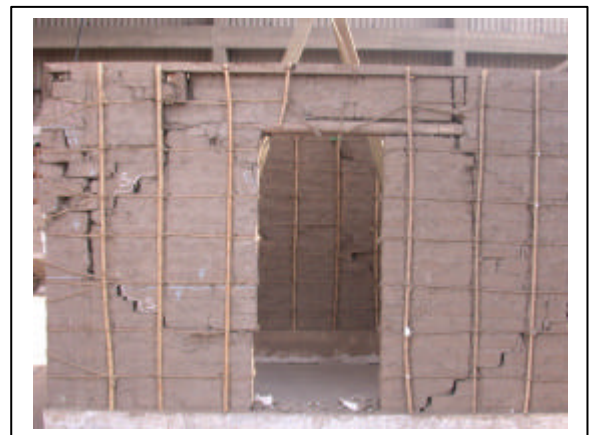
Figure 22. Model 1 East wall, The left side without plaster. Show greater damage than the right side

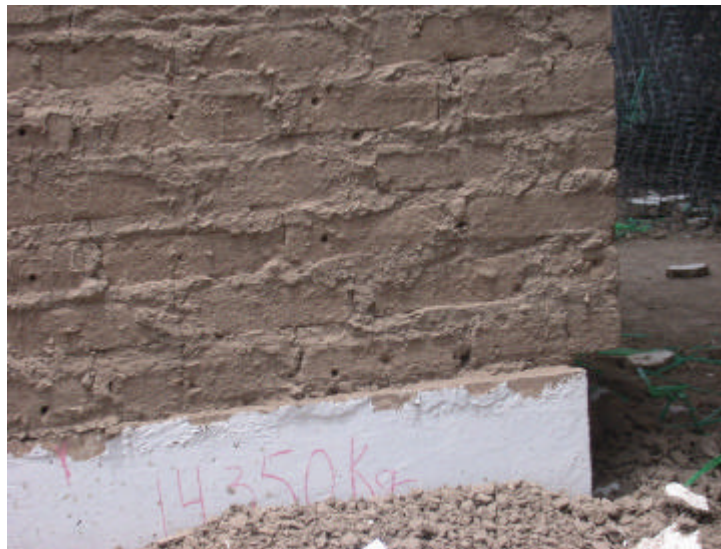
Figure 23. Sliding of the base in the North wall.

Model 2 also remained in the elastic range until phase 3, in phase 4, small cracks appeared in the walls, the cracks were more visible in the plastered side since is difficult to observe them in the side with the mesh exposed. In phase 5 the model slide from its base almost as a rigid body, without having significant damage. Phases 6 and 7, both with 1.2g of peak acceleration caused additional cracking in the walls and also sliding in the base (figure 22). After the test, only small cracking was visible in the north wall, been more significant in the south wall. See figure 23.

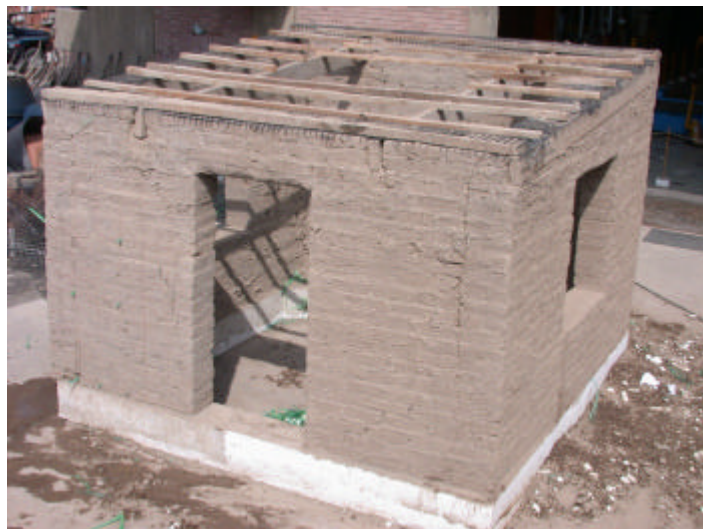
Figure 24. Model 2 after removing the plaster and the polymer mesh. The East and North wall shown here present only small cracking.

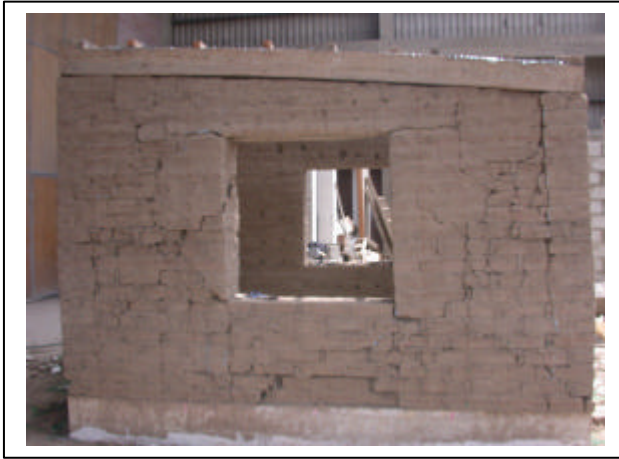
Figure 25. Model 2 North Wall without plaster. The wall is completely cracked after the test with more extensive damage in the left hand pier.

After removing the external mesh from the walls, it could be appreciated that the plastered side (North Wall) suffered less damage than the South Wall. In the case of the plastered side, the polymer mesh acted as if it were an internal reinforcement inside the stucco and the stucco adhered to the wall, so, as it has been proved in a previous research, the internal reinforcement increases the initial shear strength of the wall.

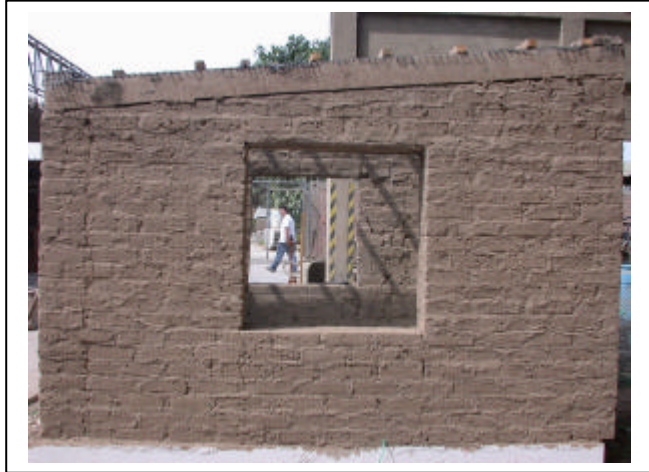
Figure 26 Model 2 South Wall, plastered side. The wall shows only small cracking with one vertical crack at the left wall intersection. See the sliding of the base at the right lower corner.

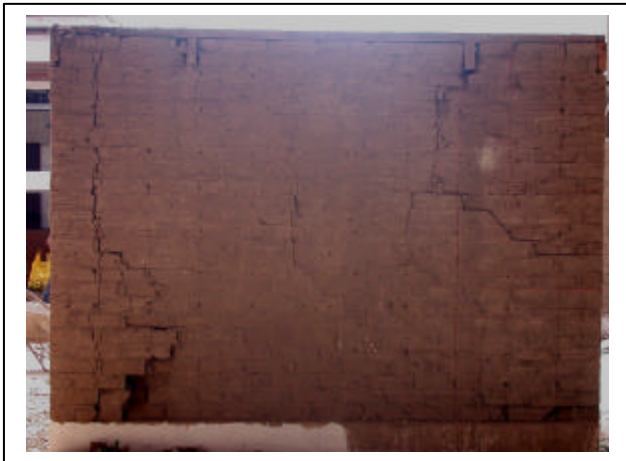
Figure 27. Model 2 West Wall. The right hand side without plaster shows cracking at mid height. The left plastered side shows damage at the lower part because the sliding of the North Wall.

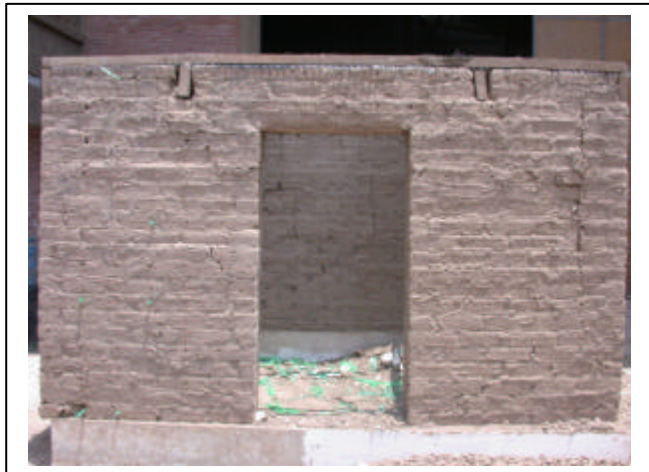
Figure 28. Model 2 East Wall. Only small cracking appear on this wall. The sliding can be seen at the lower left corner and a vertical crack in the right side.

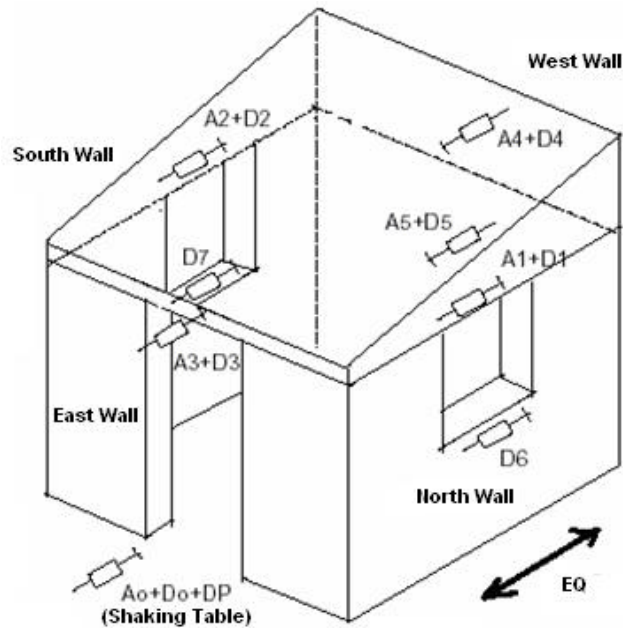
Figure 29. Instrument configuration.

In model 2 all the instrumentation was kept until the last phase with the exception of LVDT's D6 and D7, since the behavior of the model was such, that not partial collapse was expected. The instrument distribution is shown in figure 29.

Acceleration and relative displacements time histories were recorded in most of the phases at given points shown in figure 29. All time histories recorded are contained in a digital file annex to this report. The relevant information from top displacements in phase 4, Model 1 and phase 6, Model 2 are described in this section.

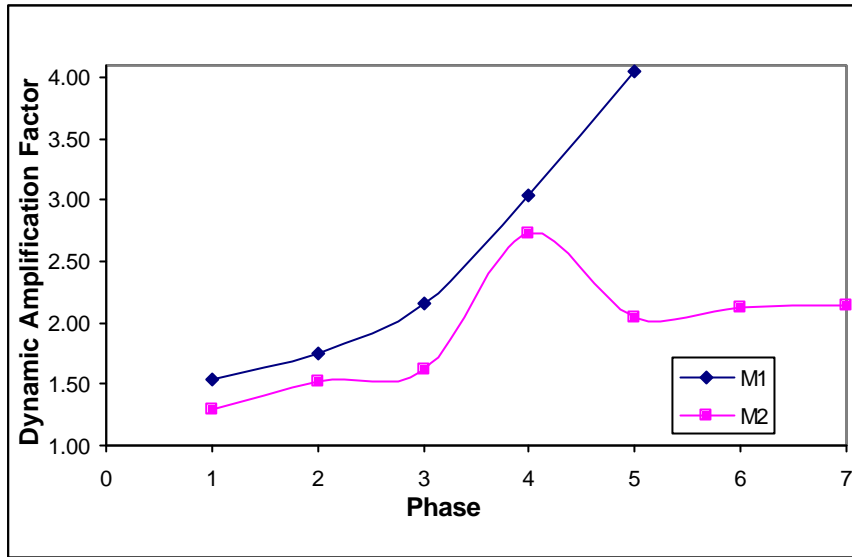
Figure 30. Dynamic Amplification Factor for models 1 and 2.

In both models the maximum accelerations were recorded at the top of the east wall and with this data the and the peak table acceleration, the Dynamic Amplification Factor (DAF) was computed. Model 1 shows an increasing DAF with the increase of table motion whereas model 1 shows a decay in the value of DAF after phase 4 as can be seen in figure 30.

The decay in model 2 can be explained by the sliding of the model that dissipated energy by friction at the base, in a similar way to the base isolated buildings.

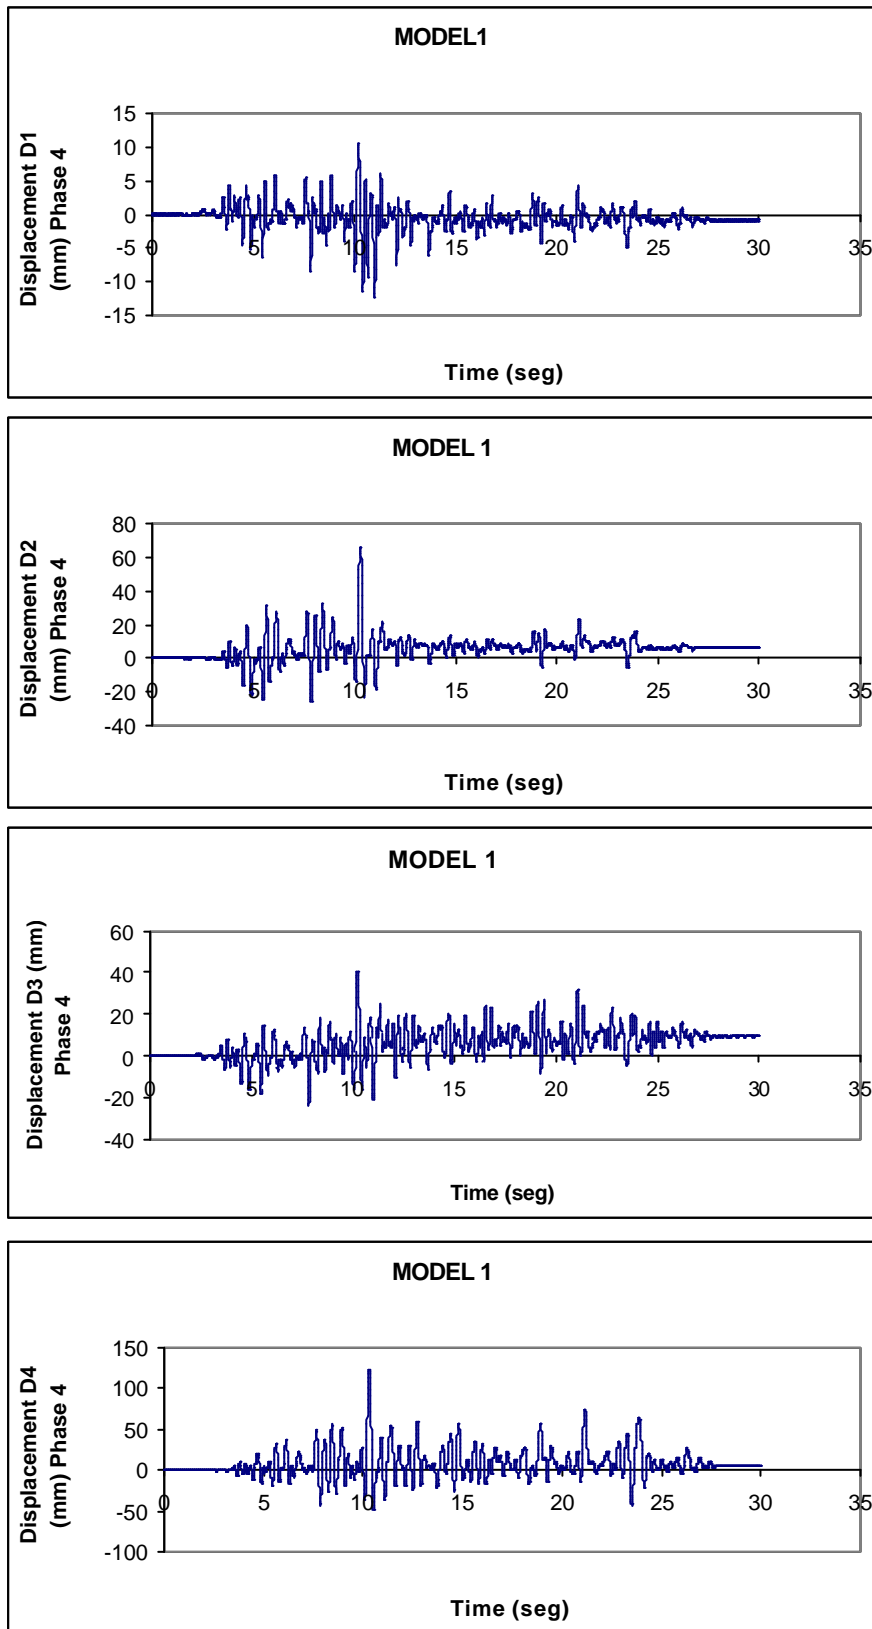
Figure 31. Displacements at top of Model 1 for phase 4.

In phase 4 of Model 1, the peak base displacement was 80 mm and the peak table acceleration 0.8g approximately, in this phase, the model start cracking at several points, mainly at both corners of west wall isolating it and producing vibrations with big amplitude, as a result of this, the time history of D4 shows bigger displacements than the rest of the roof (the maximum is 122 mm). On the contrary, the minimum displacement, ten times less, are found in the north wall (D2, maximum of 12 mm), this wall was plastered with mud and showed less cracking than the rest of the model. The south wall (without plaster) and the east wall (the door wall) showed similar time histories with 66 and 40 mm of maximum displacement respectively. In both cases the time histories show a permanent deformation which may be caused by the cracking of the walls near the point of measure. See figure 31.

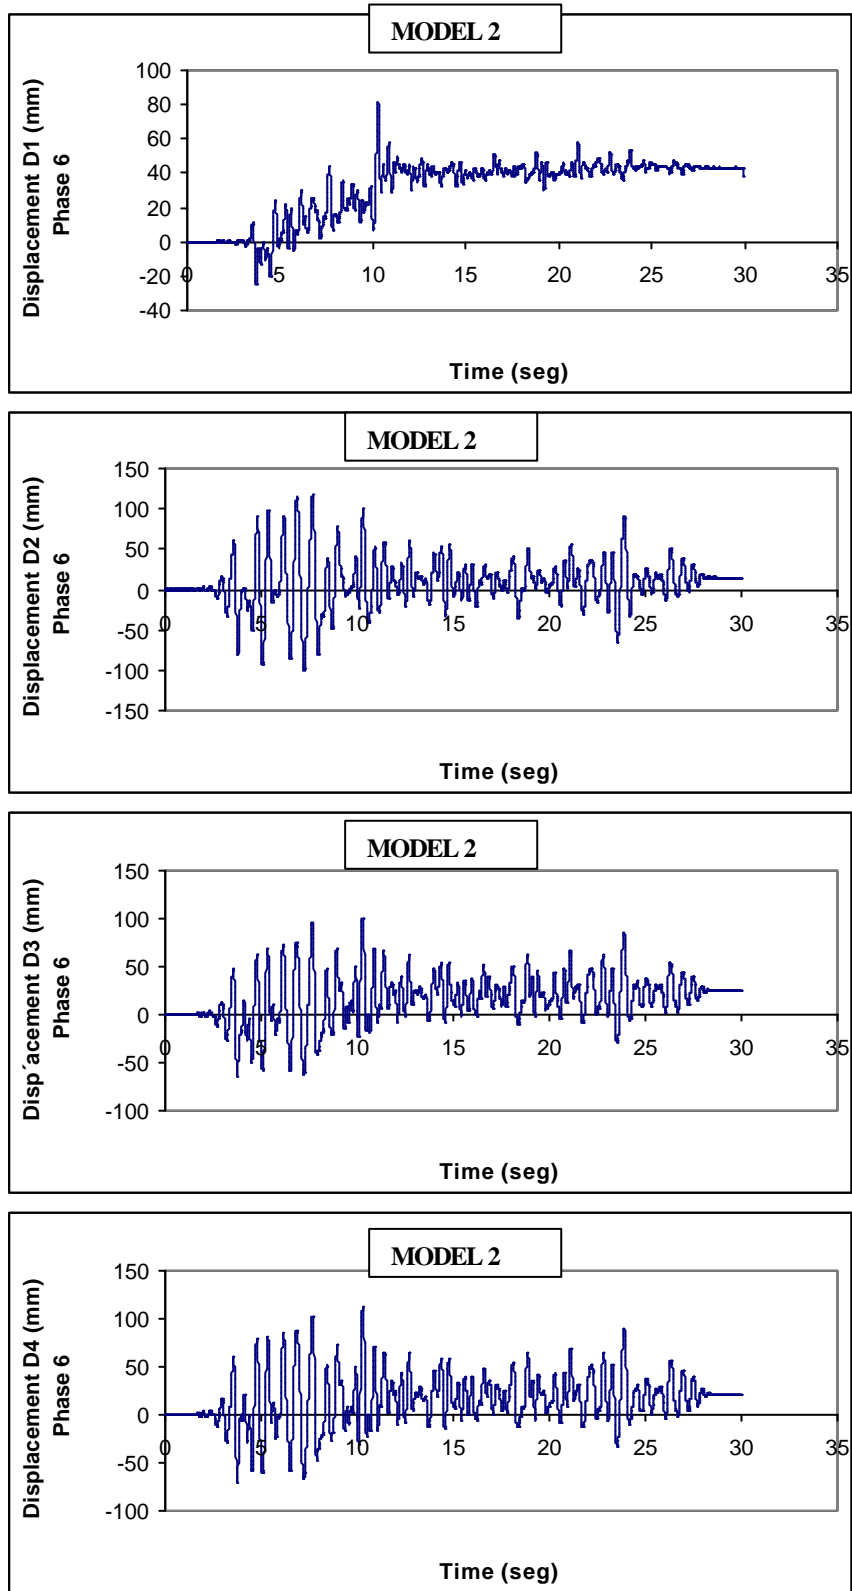
Figure 32. Displacements at top of Model 2 for phase 6.

Phase 6 in Model 2 had a peak base displacement of 120mm and a peak base acceleration of 1.2g approximately. In this phase, the north wall (D1) at about 11 seconds of motion slide in the base a distance of 40 mm approximately having after that a minimum amplitude vibration. The south wall however (D2), vibrated with the maximum top displacements during all test, being clear, the torsional motion with a rigidity center near the north wall. The south wall ended with a small permanent deformation produced by the extensive inner cracking. The west and east walls showed similar behavior, with big amplitude vibration and permanent deformations produced also by the inner cracking. See figure 32.

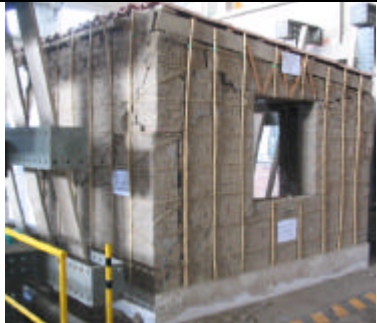
Model	Characteristics	Ultimate Behavior	Final State
M1	Exterior natural mesh, vertical cane and horizontal “cabuya” rope	Phases 5 and 6, both with p.g.a.=1.0-g: Vertical cracks at every corner, Crushing of the south wall near the lintel. Extensive cracking by the mortar joints in the east and west walls but remaining stable.

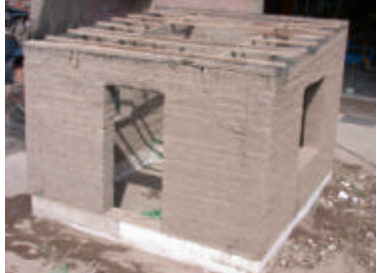
M2	Exterior industrial polymer geogrid mesh.	Phases 6 and 7 both with p.g.a.=1.2-g: Vertical cracks in every corner, moderate overall cracking, 7 cm sliding of the base at the north wall, remains in stable equilibrium.

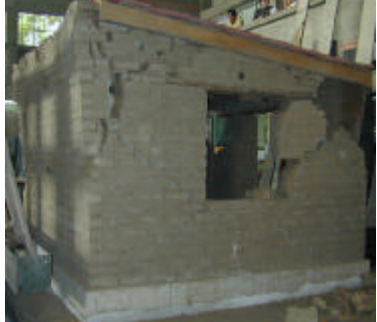
M1B	Unreinforced	Phase 4 (p.g.a= 0.8g): Extensive cracking appear in every wall, vertical cracking at the corners. Phase 5 (p.g.a.=1.0-g): Partial collapse of south-east corner, remaining in unstable equilibrium.

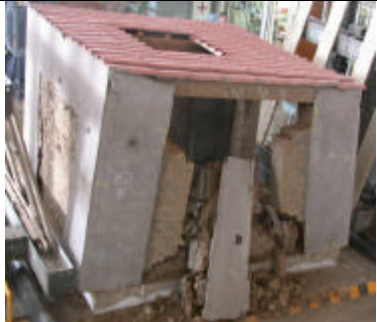
M2B	Partial exterior mesh of welded wire plus sand cement mortar	Phase 6 (p.g.a.=1.2-g): Collapse of south wall including the lintel., 15 cm sliding at the base, extensive cracking in the non plastered portions of the wall. The final state is unstable.

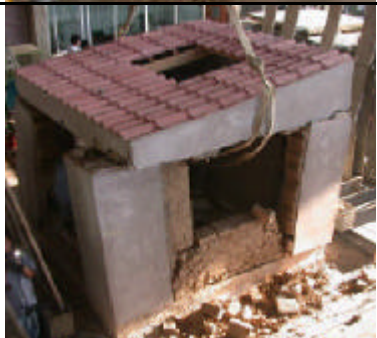
M3B	Partial exterior welded wire mesh with sand cement palster plus reinforced concrete ring beam and concrete dowels at the corners.	Phase 6 (p.g.a.=1.2-g): Shear failure at the lintel level, collapse of non plastered walls, 10 cm sliding at the base. The final state is unstable.

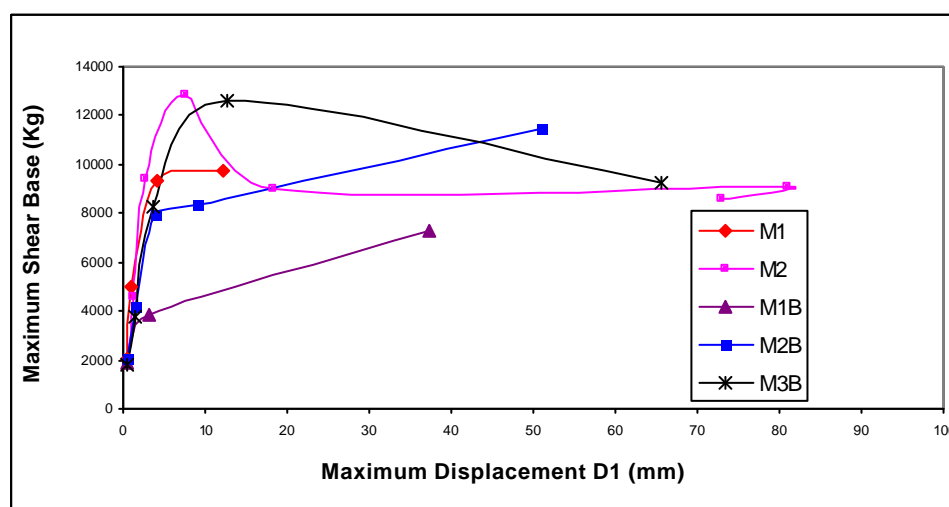
Figure 33. Pseudo P-d curves for the north wall.

Since there is not a uniform displacement at the top of model, and every wall has a different time history displacement, independent curves has been plotted for the maximum displacement in every phase, in the horizontal axis and the maximum shear base of the same phase in the vertical axis. In this way we get a pseudo Force-Displacement curve that depicts the behavior of that particular wall during the whole test. Therefore, every phase of test can be considered as an incremental value of the force related to the displacement obtained.

Figures 33 to 36 compare this pseudo P- δ curves for all models and for each wall. From these curves we can say that M2 and M3B models have the maximum shear strength (about 12,000 kg) and both increase almost three times the strength of the unreinforced model. (4,000 kg). Models M1 and M2B have also similar strength and both increase twice the strength of the unreinforced model.

In general, it can be said that the models with external mesh undergone greater deformations, being this fact notorious in the transversal west wall. For the in plane action, the M2 north wall had the maximum lateral deformation after cracking due to the sliding of the base.

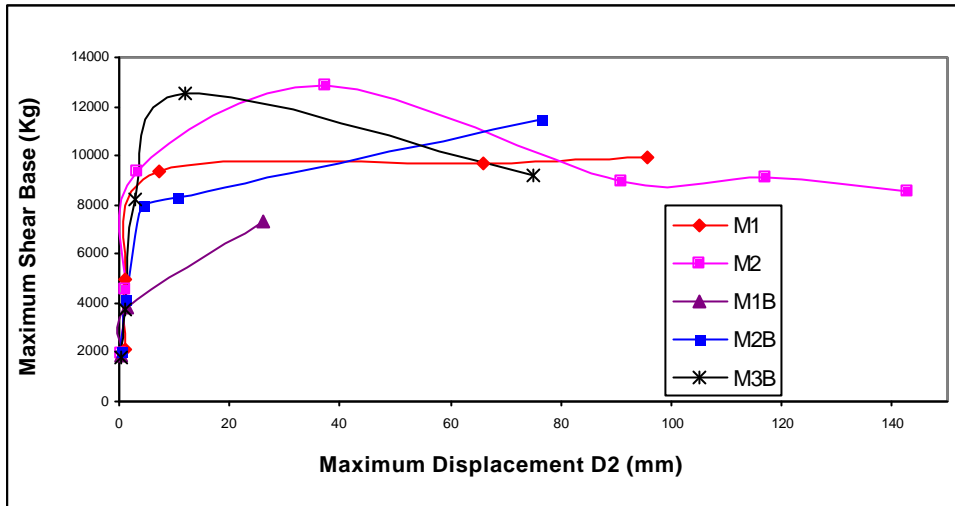
Figure 34. Pseudo P-d curves for the south wall.

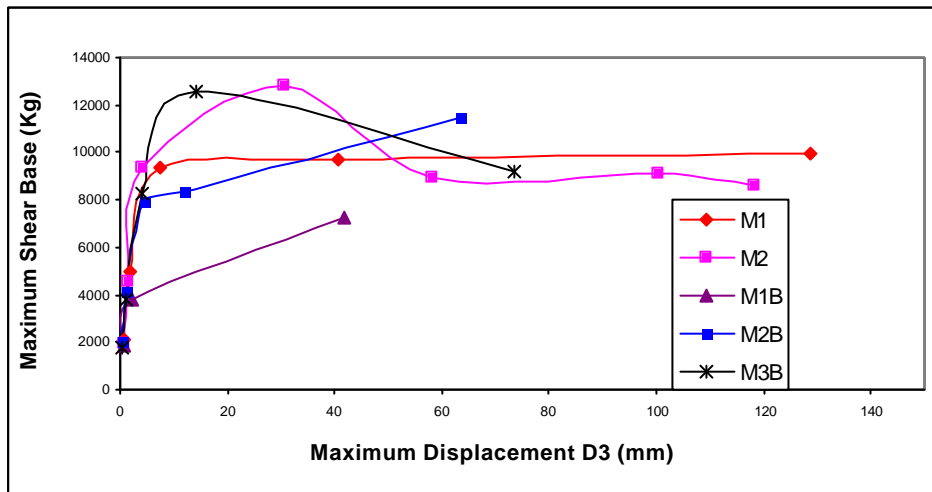
Figure 35. Pseudo P-d curves for the east wall.

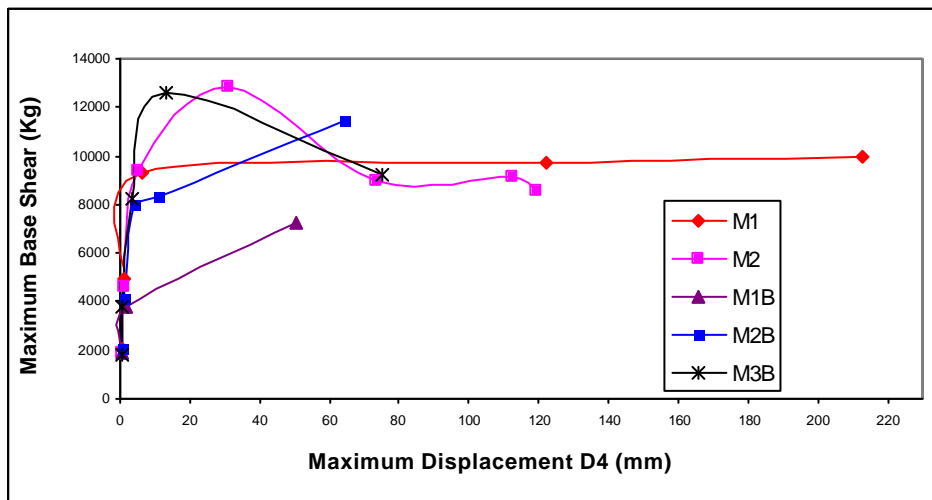
Figure 36. Pseudo P-d curves for the west wall.
